Hurricane Sandy unexpectedly hit Northeast Ohio with great force on October 29, 2012. The storm caused significant damage to the Lake Erie shoreline. One area that suffered significant damage was Burke Lakefront Airport in downtown Cleveland, OH. Burke sits right on the lakeshore and was pounded by large waves which damaged the protective rock revetment along the shoreline.

The following scope items are required for the professional services required for the design and construction of the repaired revetment at Burke Lakefront Airport:

Repair Revetment to Meet Current Design Standards

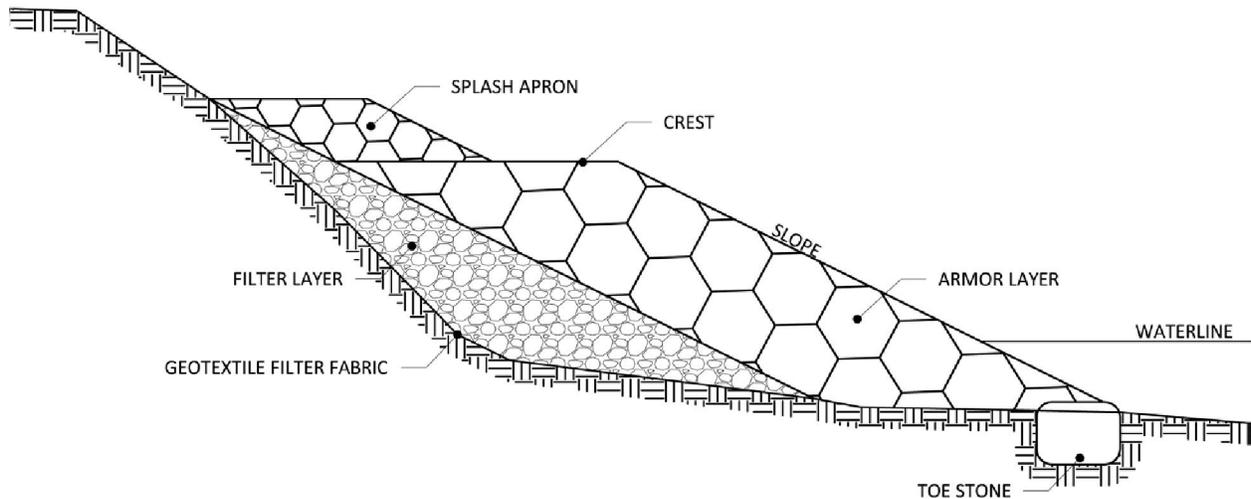
Figure 2 below from the OCDM shows an example of the typical section of a desired revetment.

Figure 2: Typical Revetment Section (Source: ODNR OCDM)

The typical section for areas that require extensive repairs, and are classified as a Grade "C", is shown below. The revetments are required to have between a 1.5:1 and 2.5:1 slope. For estimating purposes, a 2:1 slope has been assumed for recreating the existing slope. This section has an exterior ODOT "A" stone which has a size range of the largest rocks from 18"-30" diameters with an average diameter of 24". The thickness of this layer is 2 times the average diameter of the stone which is 4'. The underlying rock is recommended to be an ODOT crushed aggregate slope protection (ODOT "C" Stone) which is predominately 2.5" to 4" diameter stones. The thickness of this layer is 2 times the average size of the stone with is 2'.

Figure 2 above from the OCDM shows an example of the typical section of a desired revetment.

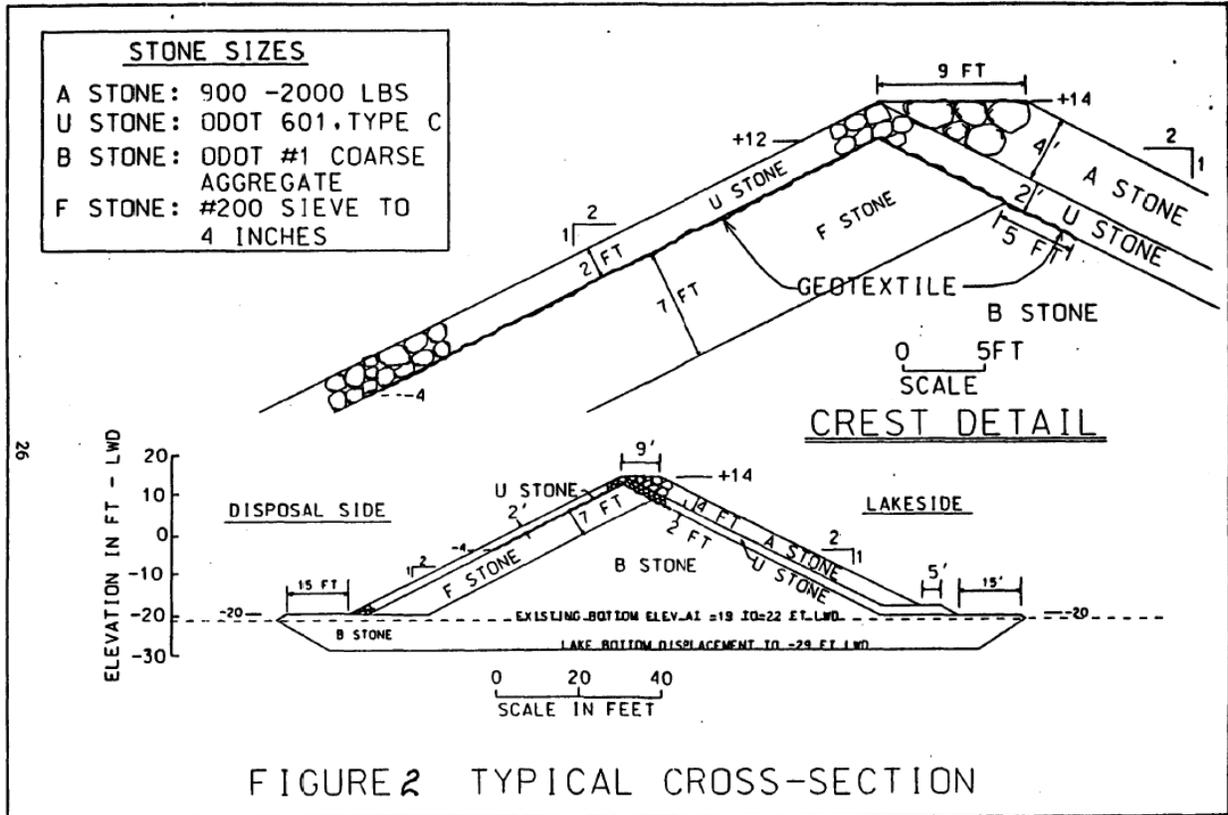
The section below in Figure 3 is the typical section used for the adjacent 10B CDF disposal site. This section was the basis for the estimate because it was specifically designed for this location on Lake Erie within the Cleveland Harbor area. The typical section below is the basis for our quantity calculation.

Figure 3: Typical Section for CDF-10 Site (adjacent property)

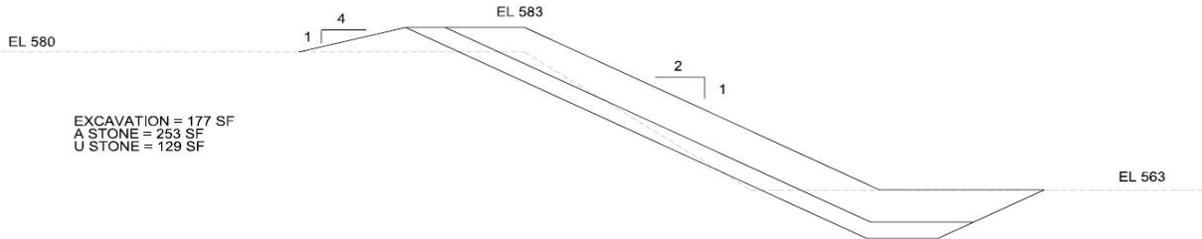
Figure 4: Typical Section Proposed Revetment up to ODNR Design Standards.

- Per each LF of shoreline it is assumed there is 253 SF of ODOT "A" stone needed for Grade "C" areas (See Figure 4).

A typical section for the full remediation was drawn and shown in Figure 4 above. This estimate assumes:

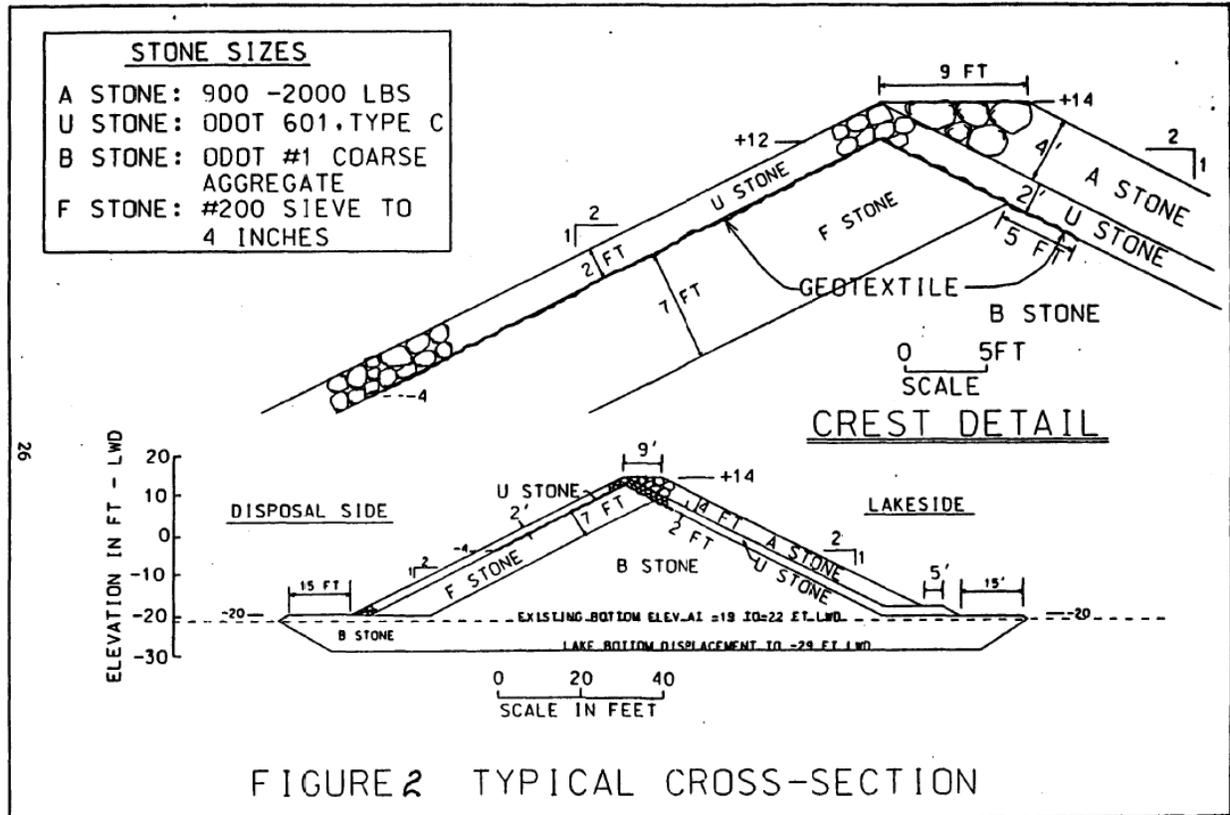
The section below in Figure 6 is the typical section used for the adjacent 10B CDF disposal site. This section was the basis for the estimate because it was specifically designed for this location on Lake Erie within the Cleveland Harbor area. The typical section below is the basis for our quantity calculation.

Figure 7: Typical Section for CDF-10 Site (adjacent property)

The typical section for the extensive repair of the revetment to provide mitigation against future storm damage is shown in Figure 7. The revetments are required to have between a 1.5:1 and 2.5:1 slope. For estimating purposes, a 2:1 slope has been assumed for recreating the existing slope. This section has an exterior ODOT "A" stone which has a size range of the largest rocks from 18"-30" diameters with an average diameter of 24". The thickness of this layer is 2 times the average diameter of the stone which is 4'. The underlying rock is recommended to be an ODOT crushed aggregate slope protection (ODOT "C" Stone) which is predominately 2.5" to 4" diameter stones. The thickness of this layer is 2 times the average size of the stone with is 2'.
